Affected Equipment: Omega Container-System XXS, XS, S, SS, M, L und XL

Reason: One or more Lines were entangled with main container flap No. 2
(See drawing page 2)

Entry in the reserve data card: „ Bartec in accordance with Service Bulletin SB-O-200501 “.

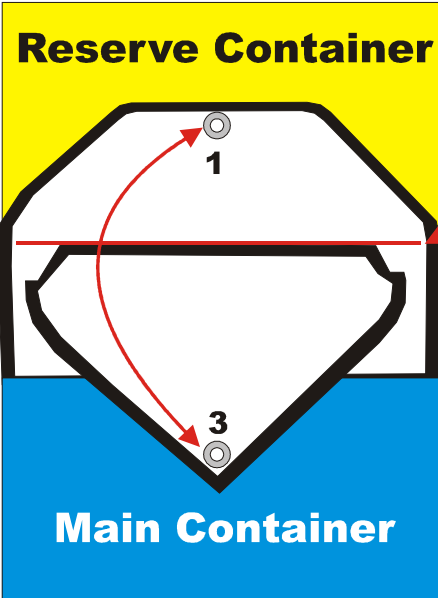
Analysis: A combination of a couple of facts can cause line entanglement with flap No. 2 of the main container.

Reasons for these failure can be:

1. Wrong size or old rubber bands.
2. To much not stowed or misplaced line length inside the main container.
3. Opening of the main container in slightly head up or stand up position.

To avoid failure like written above and during improper use of the equipment in the future, the mirror (Flap No. 3 of the reserve container) must be sewed at the round corners with two short bartec to the flap No. 1 of the reserve container. This avoid contraction of the flap under tension while a line is tucked under. And it is easier to turn up the flap to release a line.

1. Mark out horizontal above the attachment of flap No. 3.
2. Put the grommets congruent on each other.
3. Apply a bartec (left and right) on the binding tape of flap No. 3 in the same height as the horizontal marking.
